Manhole Inspection Summary

Manhole # S25KK_031MH

Record Plat: **25KK** Node: **031** Status: **Found**

Location Address: **NORTH AVE**

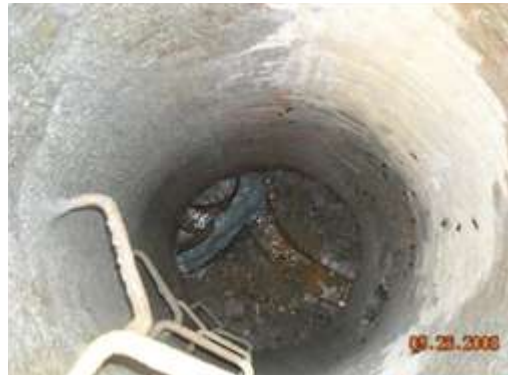
Top View

Corroded steps. Adjustment and Barrel infiltration. Bench and Channel debris.

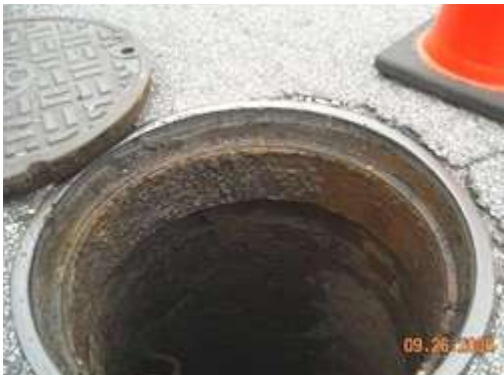
Defect

Frame leaks. Adjustment infiltration.

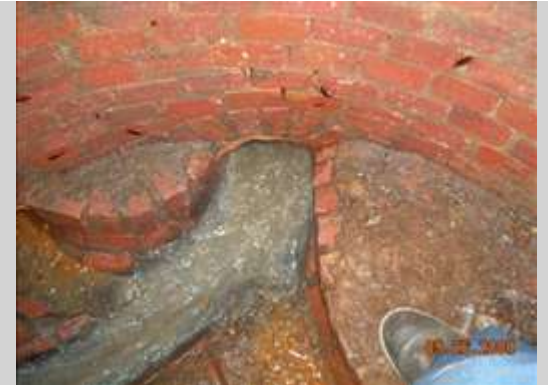
8 in. Circular Gravity Sewer Pipe Out @ 12 O'Clock

Infiltration: **None** Pipe Seal Cond: **Unknown**

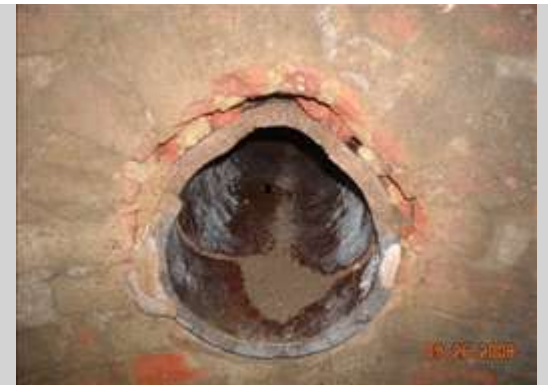
8 in. Circular Gravity Sewer Pipe In @ 4 O'Clock

Infiltration: **None** Pipe Seal Cond: **Broken**

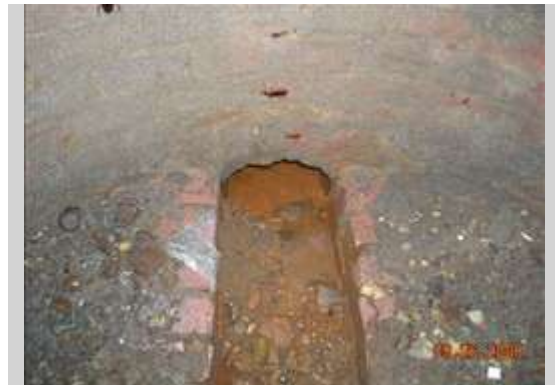
Drop In @ 4 O'Clock

Drop Condition: **Open**

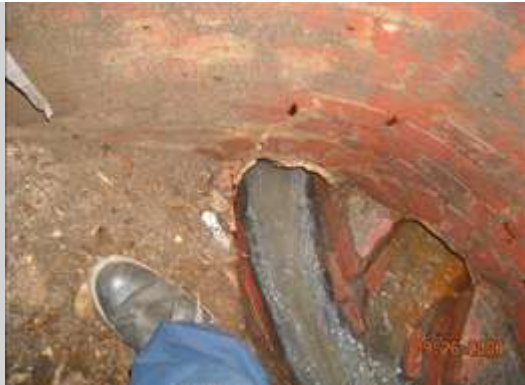
Pipe In @ 8 O'Clock

Infiltration: **None** Pipe Seal Cond: **Cracked**

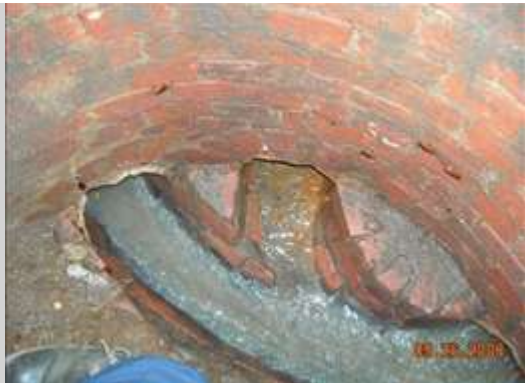
Pipe In @ 10 O'Clock

Infiltration: **None** Pipe Seal Cond: **Unknown**
